MEMORANDUM

SUBJECT: Conclusions: Certain-Teed Transite Pipe
A.K.A Maline Creek, 600 St. Cyr Road, St. Louis, Missouri
TDD#: T07-9203-012A
PAN#: EM00307SAA
EPA/OSC: Mark Roberts

SUBJECT: Site Assessment: Certain-Teed Transite Pipe
A.K.A Maline Creek, 600 St. Cyr Road, St. Louis, Missouri
TDD#: T07-9203-012
PAN#: EM00307SAA
EPA/OSC: Mark Roberts

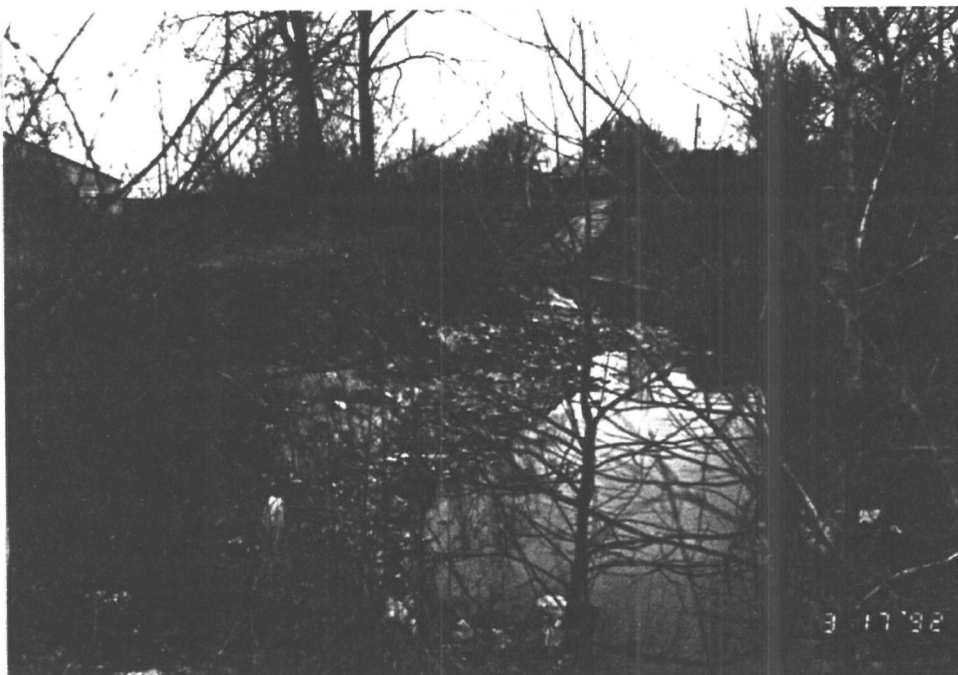
Photographer: Joe Parish
Date/Time : 3/17/92/1215
Lens: Type: 50mm/normal
Serial No.: 1063023
Frame No. : 1
Direction : E
Comments :
South of former GAF, north
bank of creek

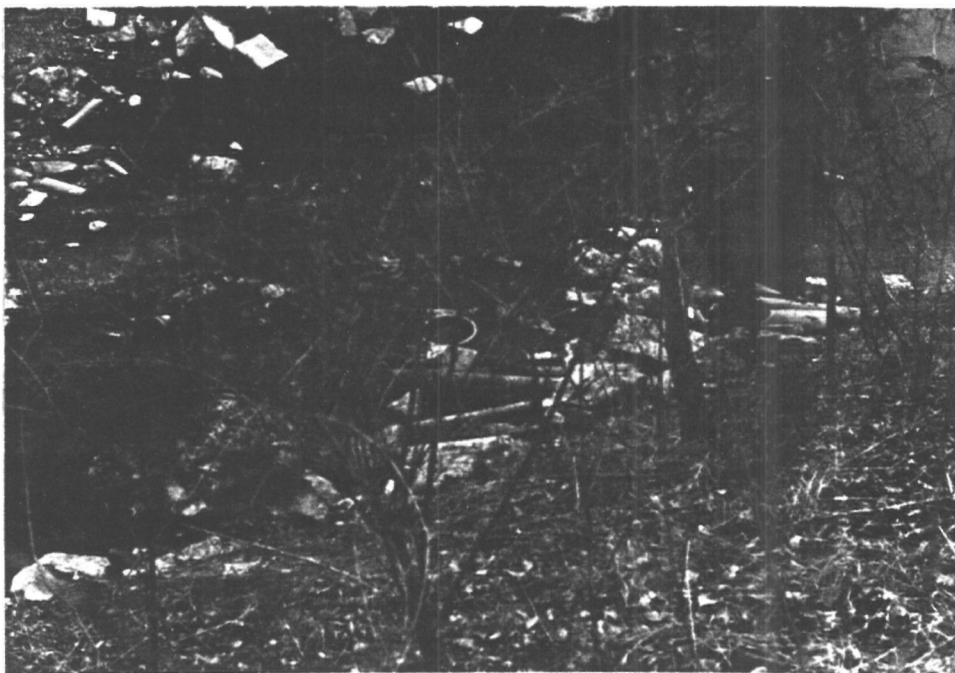
Photographer: Joe Parish
Date/Time : 3/17/92/1217
Lens: Type: 50mm/normal
Serial No.: 1063023
Frame No. : 2
Direction : S
Comments :
North edge of creek, SW of
Certain-Teed

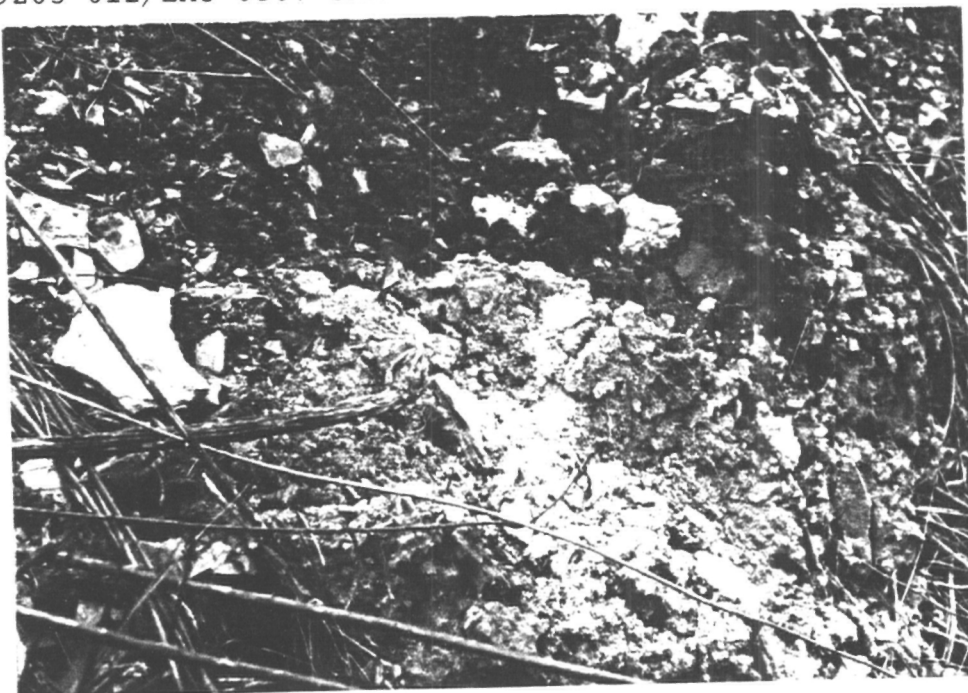
to be sheeting was visible in the rip-rap area. What appeared to be insulation material had been exposed by erosion at the upper bank of the creek. Both this material and the sheeting were sampled (sample numbers 005 and 006, see the site map for location). The insulation material was friable and particles became airborne during sample collection. The sheeting appeared hard, stable, non-friable, and was sparsely scattered throughout the rip-rap.

Photographer: Joe Parish
Date/Time : 3/17/92/1220
Lens: Type: 50mm/normal
Serial No.: 1063023
Frame No. : 3
Direction : SE
Comments :
North bank, apparent
insulation, sample 5 location

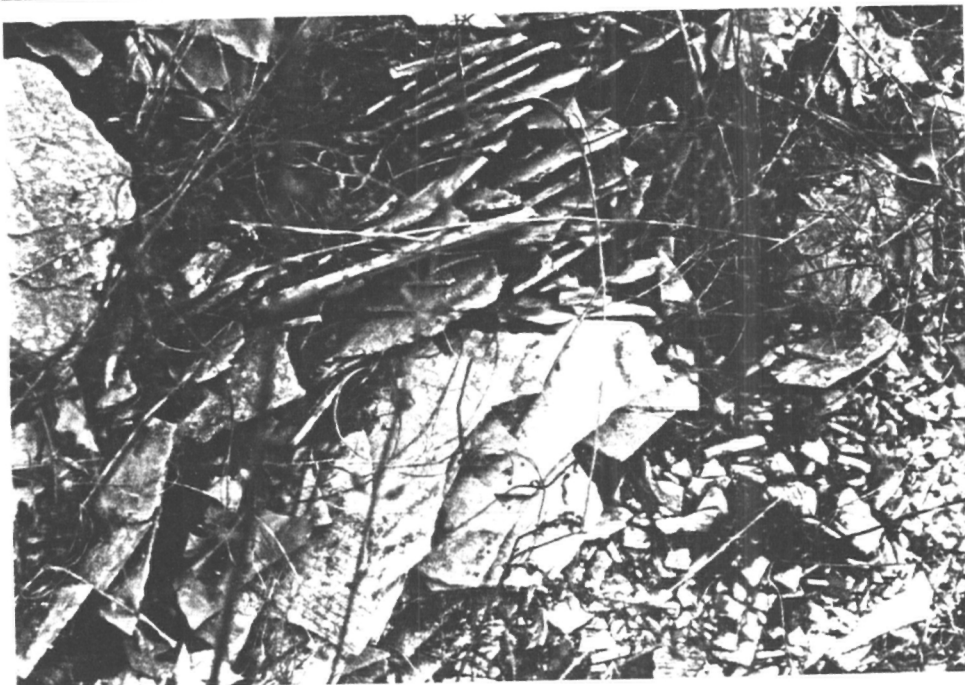
Photographer: Joe Parish
Date/Time : 3/17/92/1230
Lens: Type: 50mm/normal
Serial No.: 1063023
Frame No. : 4
Direction : SE
Comments :
North bank, sample 6 location

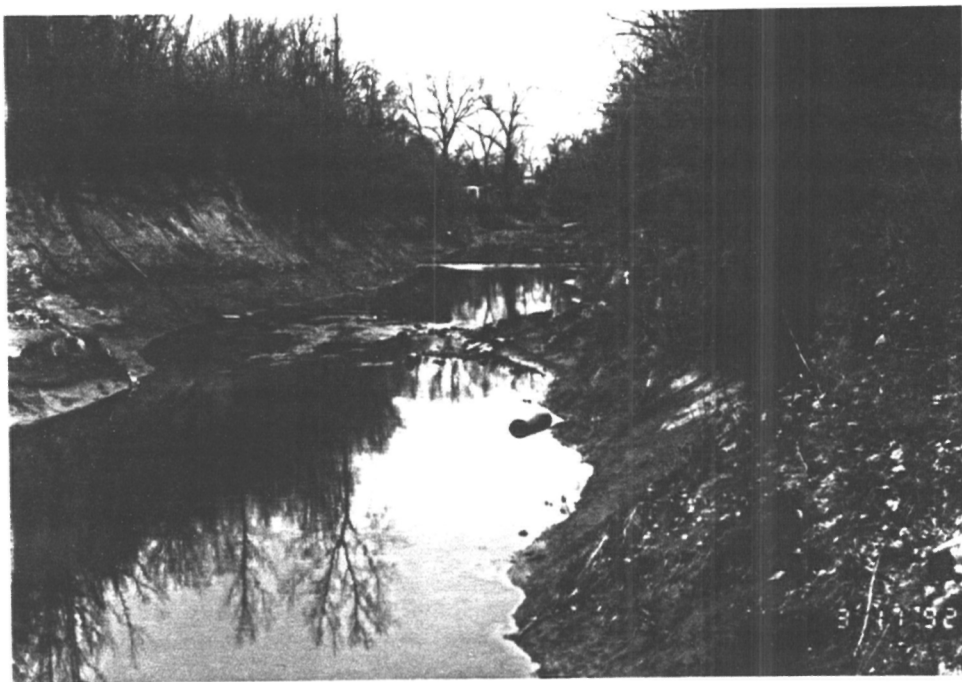
Next, TAT walked along the upper and lower banks of Maline Creek. TAT observed large quantities of transite pipe scrap material scattered down to the creek bed and extending downstream to approximately the neighboring property boundary. The upper bank of the creek appeared to be eroding, exposing more transite pipe scrap. The scrap material appeared to derive from a berm built up along the edge of the upper creek bank, presumably to cover the transite scrap. Sample number 003 was taken at this location (see site map). Transite pipe was scattered on both the near and far banks of the creek, as well as in the creek bed. A composite sample (number 004) was collected from material at these locations. The transite scrap appeared to be in two forms - scrap of the pipe itself, and scrap of the ring connectors that joined the pipe sections. The connectors were slightly friable. The pipe scrap was very hard and could only be broken by using a sledge hammer. In either case, fibers were observed sticking out of the weathered broken edges of pipe scrap.

Photographer: Dave Kinroth
Date/Time : 3/17/92/1240
Lens: Type: 50mm/normal
Serial No.: 1063023
Frame No. : 5
Direction : NW
Comments :

Transite pipe and connectors,
north creek bank south of
former Certain-Teed

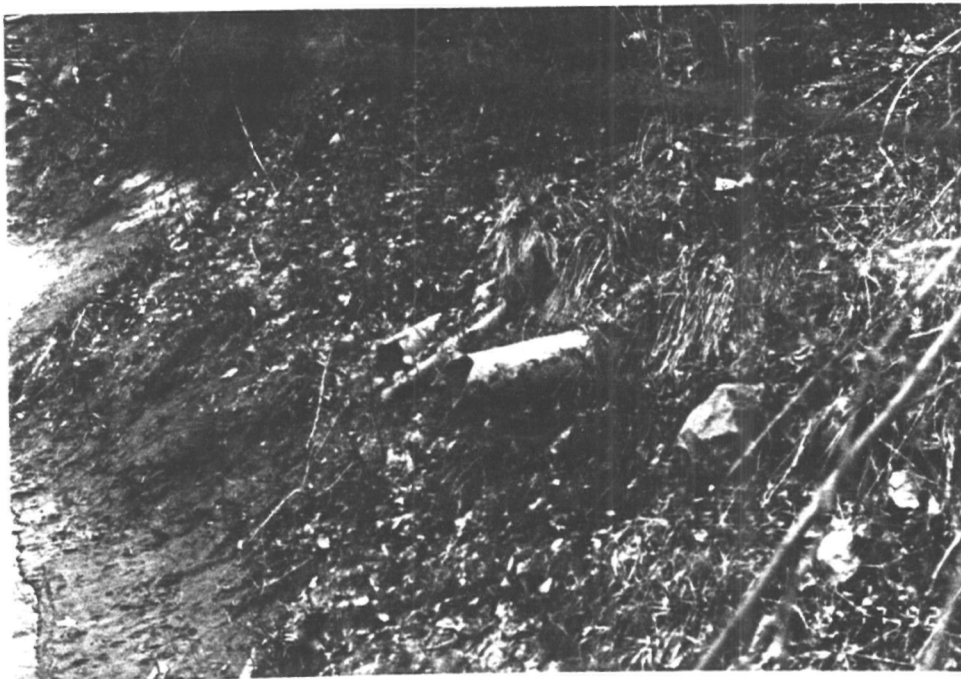
Photographer: Dave Kinroth
Date/Time : 3/17/92/1241
Lens: Type: 50mm/normal
Serial No.: 1063023
Frame No. : 6
Direction : NW
Comments :

Transite pipe and connectors,
north creek bank south of
former Certain-Teed

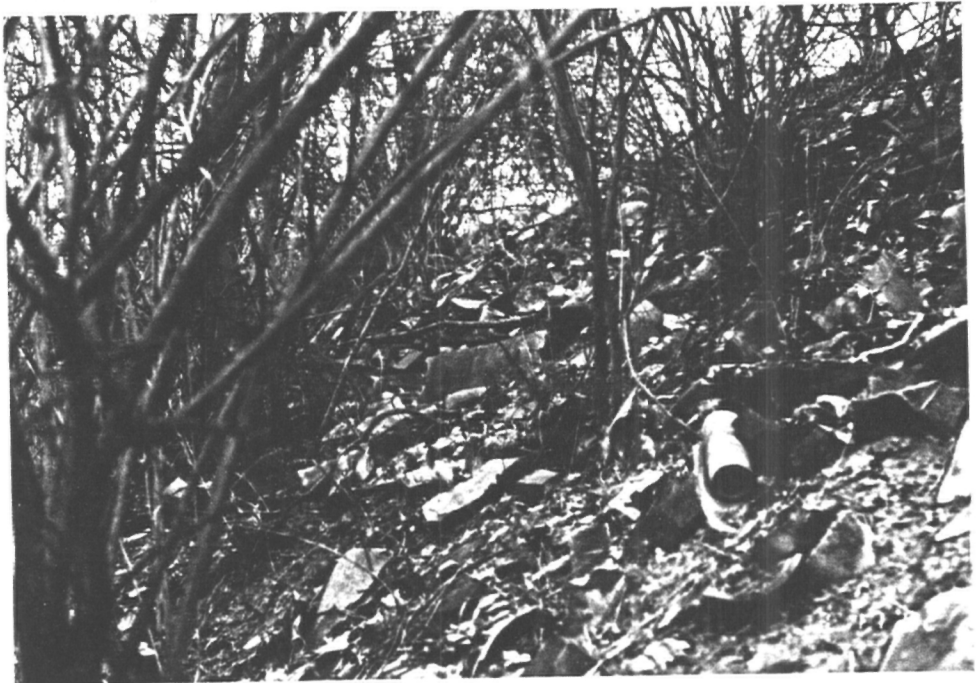
Photographer: Dave Kinroth
Date/Time : 3/17/92/1242
Lens: Type: 50mm/normal
Serial No.: 1063023
Frame No. : 7
Direction : NW
Comments :
Transite pipe and connectors,
north creek bank south of
former Certain-Teed

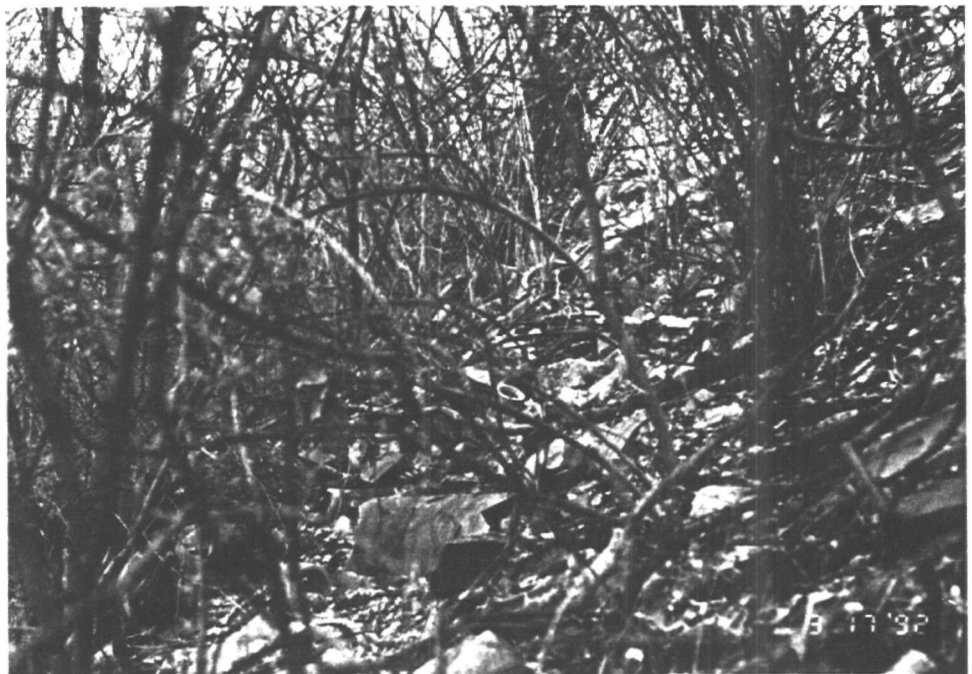
Photographer: Dave Kinroth
Date/Time : 3/17/92/1243
Lens: Type: 50mm/normal
Serial No.: 1063023
Frame No. : 8
Direction : NW
Comments :
Transite pipe and connectors,
north creek bank south of
former Certain-Teed

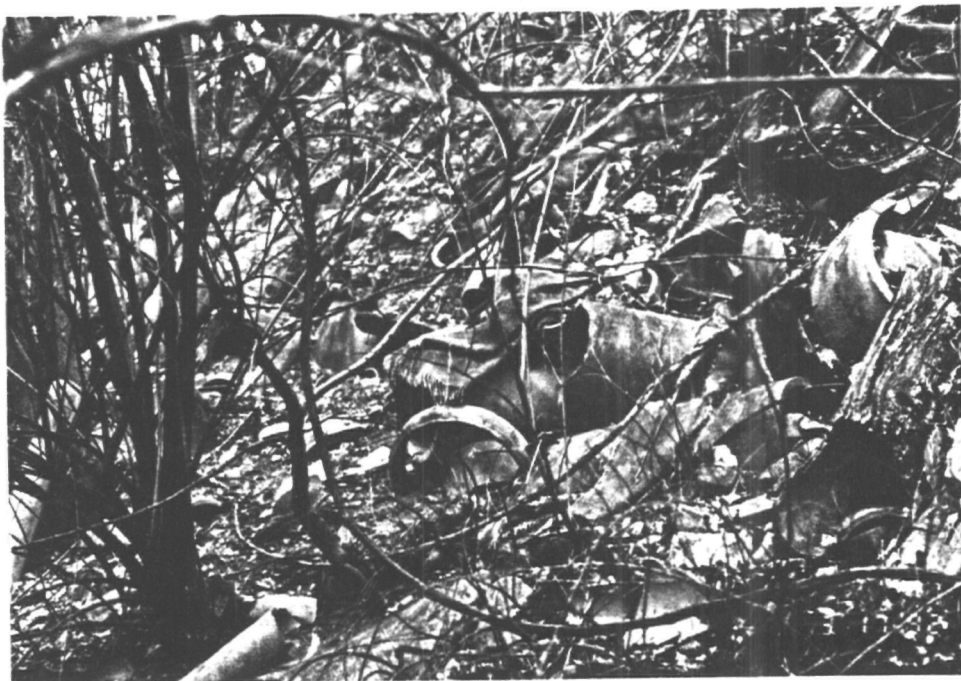
Photographer: Dave Kinroth
Date/Time : 3/17/92/1243
Lens: Type: 50mm/normal
Serial No.: 1063023
Frame No. : 9
Direction : NW
Comments :
Transite pipe and connectors,
north creek bank south of
former Certain-Teed

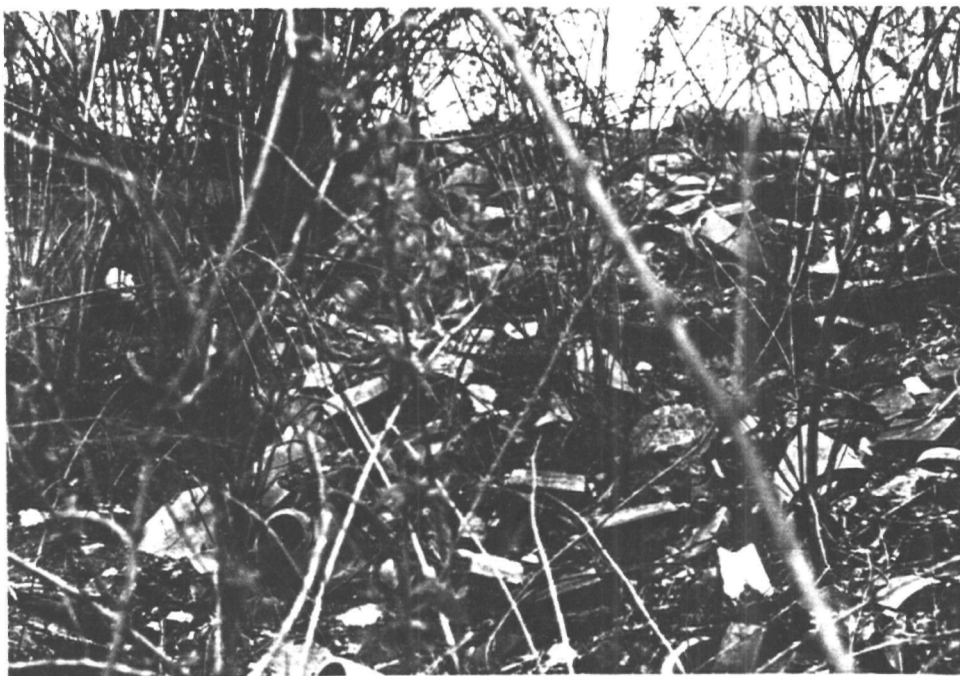
Photographer: Dave Kinroth
Date/Time : 3/17/92/1244
Lens: Type: 50mm/normal
Serial No.: 1063023
Frame No. : 10
Direction : NW
Comments :
Transite pipe and connectors,
north creek bank south of
former Certain-Teed

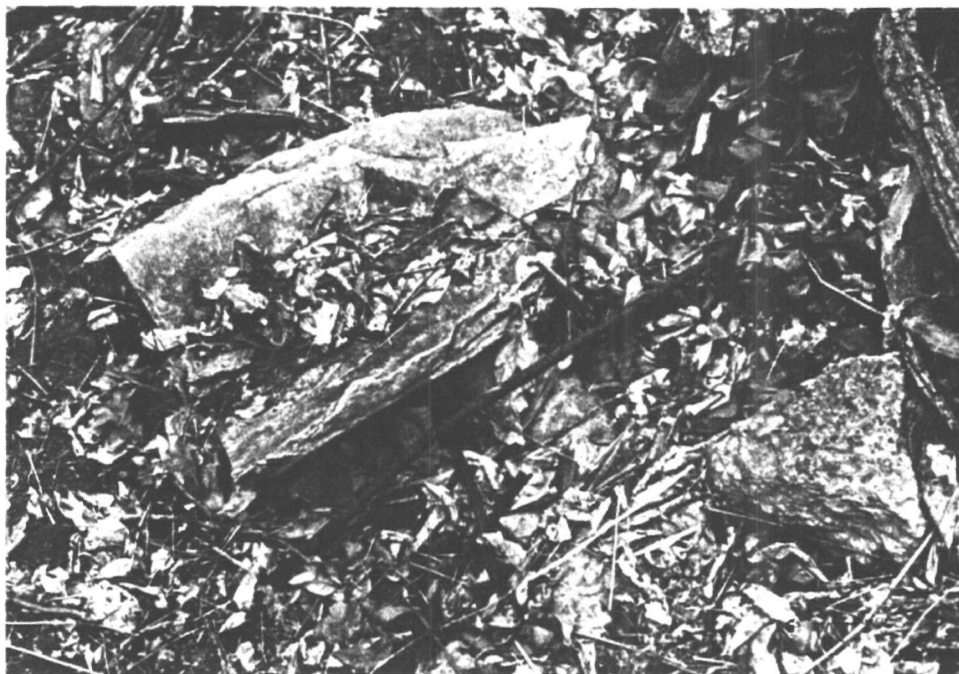
Photographer: Dave Kinroth
Date/Time : 3/17/92/1245
Lens: Type: 50mm/normal
Serial No.: 1063023
Frame No. : 11
Direction : NW

Comments :
Transite pipe and connectors,
north creek bank south of
former Certain-Teed

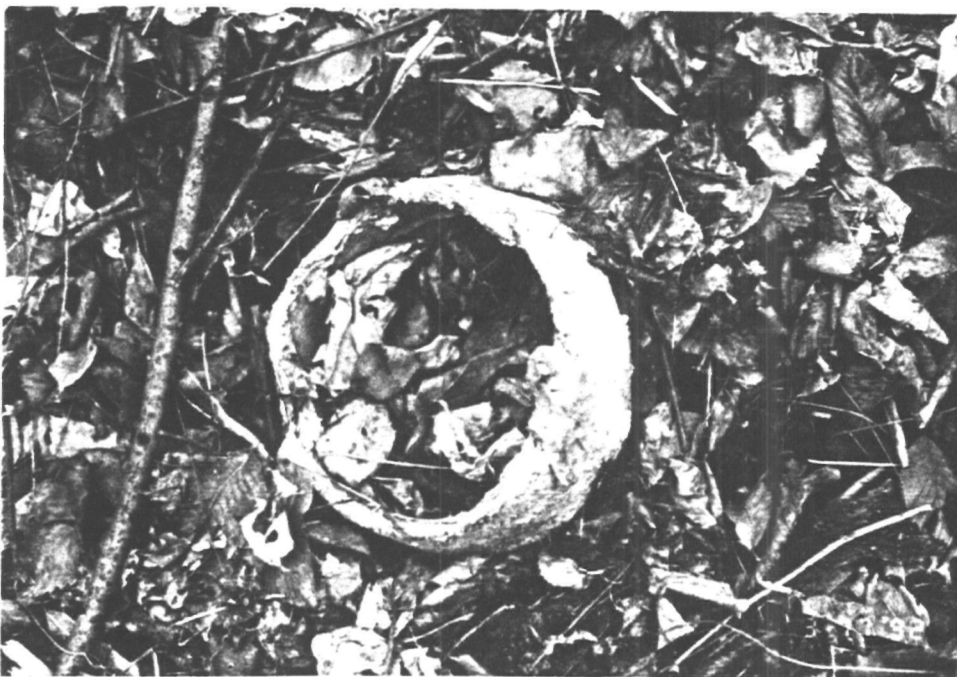
Photographer: Dave Kinroth
Date/Time : 3/17/92/1245
Lens: Type: 50mm/normal
Serial No.: 1063023
Frame No. : 12
Direction : NW

Comments :
Transite pipe and connectors,
north creek bank south of
former Certain-Teed

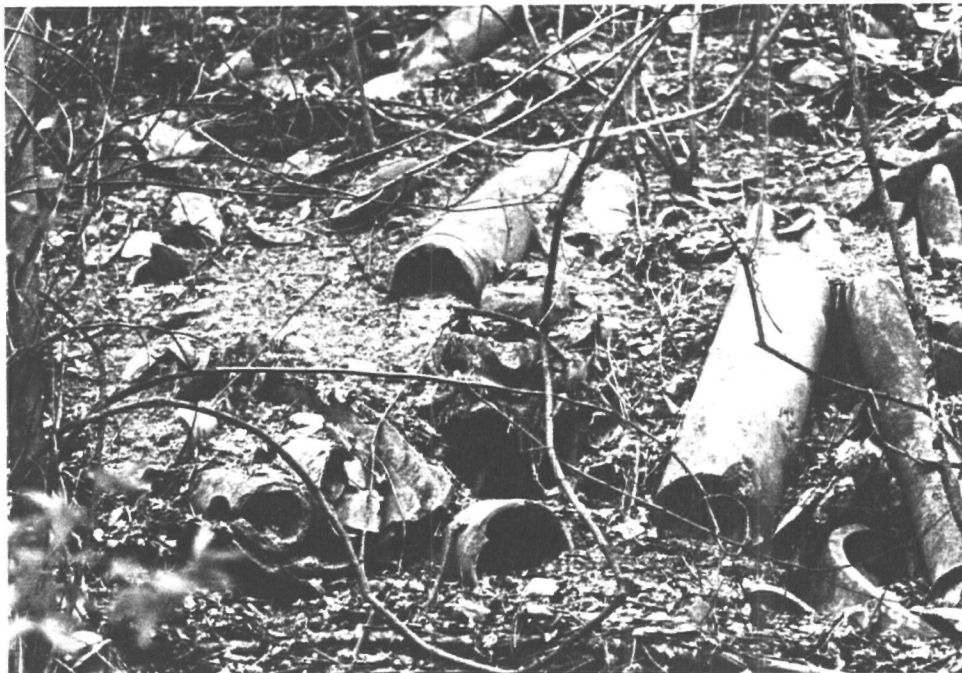
Frame No. : 13

Transite pipe and connectors,
north creek bank south of
former Certain-Teed
